Project: **Design/Engineering Services –
BPCPC Mechanical System
Upgrade**

RE: **Addenda #1**
of Pages: **26**

1.0 Background

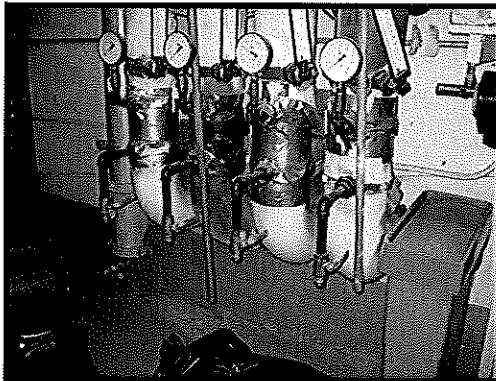
Photo 1 shows the piping from the SCWs and the sample spigot from which a groundwater sample was obtained for laboratory analyses. Photo 2 shows the well water filters. It is unknown from which of the two wells the sample was drawn as a well location map was not available at the time of the sampling.

Photo 1. SCW sampling location

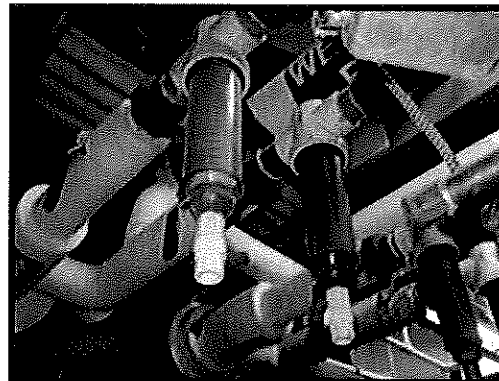
The well water supply piping has several small strainers installed. It was noted by the operators that whenever the automatic filter blowdown valves would open, the water-to-water heat pumps would shut-down. This is likely due to loss of flow to the heat pumps, as the blowdown line would 'starve' the system of water.

Photo 2. SCW water filters

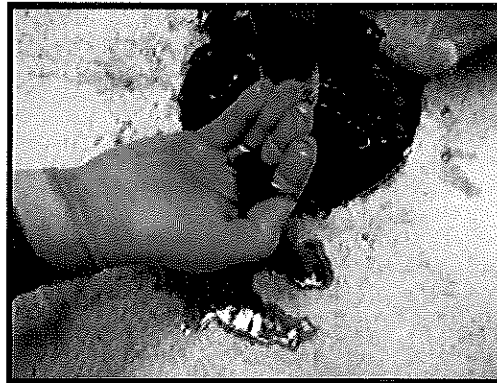
The water that first flowed from the sample spigot was black, with a slight brackish odor (Photo 3). The water contained fine black sediment and was tepid to the touch. The discharging water did not clear after approximately 10 minutes of pumping. After an hour of circulated water a sample was collected that was clear with minor rusty orange suspended particles and had no odor.

Photo 3. Well water sample

The analytical results were evaluated for corrosion and scale using both the Ryznar Stability Index and Langelier Index which produced values of 8.4 and 0.33, respectively. These values indicate that the water has heavy corrosion potential and some scale potential (see index sheets in Appendix B).

We can conclude from the well completion reports and the analytical results that the SCW portion of the geothermal HVAC system is not capable of providing sufficient heat exchange with the earth to support the 90 tons of peak load demand. The two SCWs combined are more likely capable of providing heat exchange to support approximately 30 tons of peak load demand. The groundwater quality results indicate, based on the Ryznar Stability Index of 8.4, that the water is aggressive or capable of heavy corrosion.

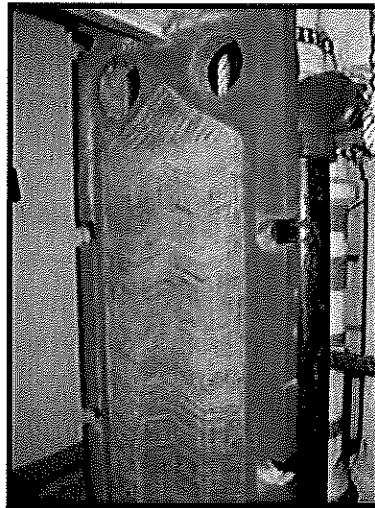
Heat exchanger HX-1 was originally intended to provide free cooling to the AHU-1 free cooling coil and the radiant floors for free cooling. Per our discussions with the operators, the radiant floor free cooling system never operated satisfactory in that condensate formed on the floors making the system unusable. In addition, the heat exchanger plates were severely corroded by contact with the well water and eventually failed (Photo 4). At the time of our site visits, HX-1 had already been disassembled and taken out of service.

Photo 4. HX-1 disassembled

- Reactivation and retro-commissioning of the well pumps. Possible replacement if existing pumps are not serviceable.
- New Titanium Plate/Frame HX-1 (30 tons)
- New well-water filtration system to provide longevity of HX-1 life.
- New 3-way valve to allow bypass of HX-1 during winter time.
- New controls and BMS programming to support free cooling operation.
- Reactivation/Retro-commissioning of AHU-1, 30 ton free-cooling coil.
- Replace corroded well water piping in mechanical rooms with plastic or corrosion proof pipe (PE or PVC) wherever possible.

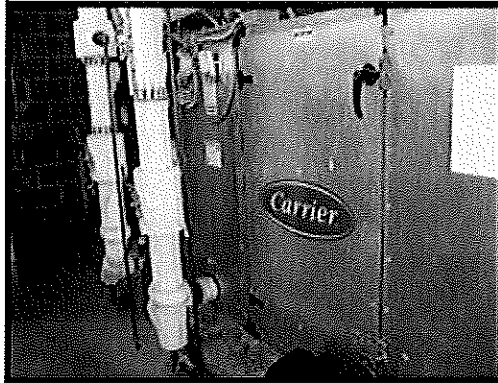
OLA and Avcon conducted field testing to observe the problems. It was observed that when AHU-1 is activated it implodes/collapses the fresh air intake (FAI) ductwork that is connected to the mixed air plenum box of the other air handling units. AHU-1 is operating at a 2" negative pressure at the intake plenum box. OLA confirmed during an operational test

Photo 5. AHU-1

- Provide new required fresh air intake (FAI) ductwork to the AHUs, modify and/or increase the FAI, return and mixed air duct connections to the AHUs and the existing mixed air plenums.
- Provide adequate cross bracing for the existing FAI ductwork per SMACNA requirements. Replace sections of imploded fresh air intake duct where necessary.
- Consider in-line return air fans and ductwork in order to improve return air (RA) flow to AHUs 2 - 5. The 4th Floor office unit appears to be in need of a return fan and the others should be reviewed.
- Provide testing and balancing for AHUs, including balancing to meet the economizer conditions.
- Revise control systems and sequence of operations to interlock new FAI and return air fans with AHU-1 and other AHUs.

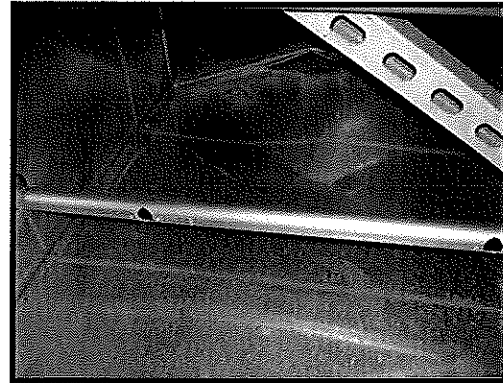
that when AHU-1 is active, the other air handling units all exhibit backwards airflow through the fresh air intake ducts. This results in loss of ventilation to the rest of the building. It was also noted that the outside air intake duct to AHU-4 was imploded and in need of repair. (Photo 6)

Photo 6. Imploded outside air intake duct to AHU-4

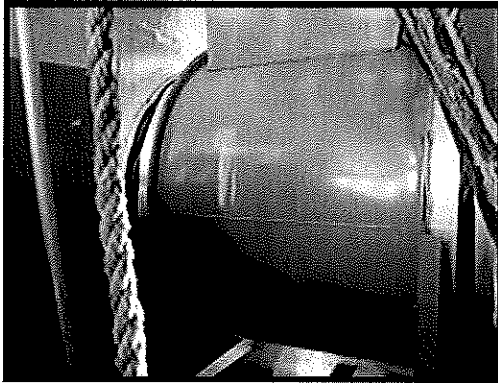
At the time of our site visits, the fresh air fan (FAI-1) had been taken out of service, the ductwork disconnected, and the air intake duct was left open to the 11th floor roof mechanical shed area. (Photos 7 & 8) It was not clear why the original FAI fan was taken out of service. It is possible that it was taken out of service due to the generator exhaust being recirculated in the fan, but this could not be confirmed (refer to Section 2.5).

Photo 7. Fresh air fan (FAI-1)

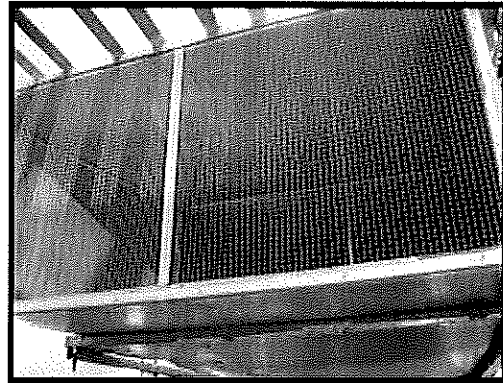
Photo 8. FAI-1 air intake duct

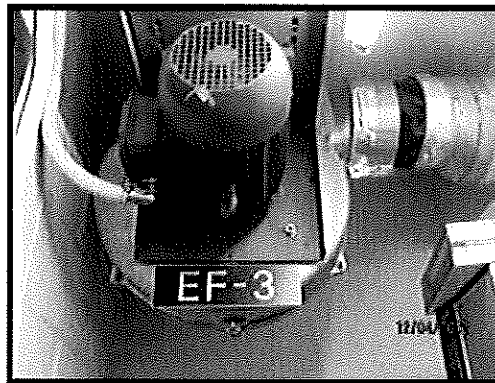
It was noted by the operators that the existing vehicle capture exhaust system is not working properly. From our inspection of the design drawings, it appears that the location of the exhaust fan EF-3 is not correct and must be relocated downstream of all the hose reels in order for the system to work correctly. In addition, it was noted that the existing hose reels do not have end-caps to close off hoses that are not currently being used (Photo 10).

Photo 10. Exhaust fan EF-3

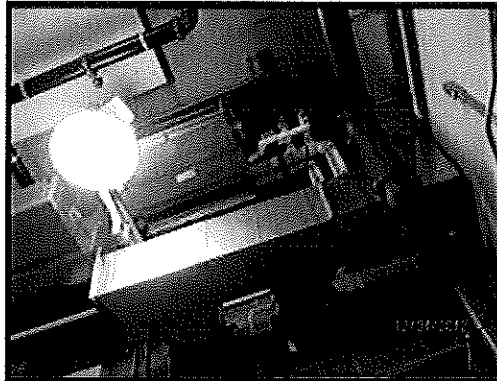
Presently, the air conditioning for the main lobby produces temperatures that are too hot in the summer, and too cold in the winter, indicating that cooling and heating capacities may be inadequate. Air conditioning is provided from fan coil unit FCU-2 (Photo 11). Ventilation air is provided from AHU-1 that is designed to supply air at 68°F, essentially compromising the lower temperature supplied from FCU-2. Heating is provided from a wall cabinet unit heater CUH-A (17 MBH). It was also observed that the horizontal fan coil unit FCU-2 is located in the garage maintenance area, thus pulling garage air into the Lobby.

Photo 11. Fan coil unit FCU-2

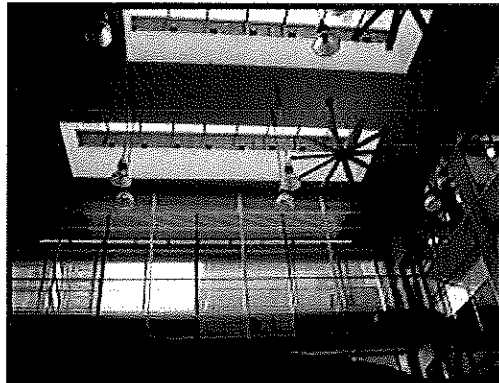
Photo 12. Proposed location for new chillers

Our recommendation is to install four (4) x 18 ton, packaged air-cooled Multistack chiller units. The proposed location of these chillers would be located in a new 4th floor Mechanical Equipment Room located above the open atrium area on the 4th Floor, below the skylight, and adjacent to the existing 4th floor catwalk (Photo 12). Other locations may be proposed by the BPCPC but would require floor space inside the building in a location accessible to the outside for fresh air/exhaust air.

This location was selected because it allows ready access to the exterior to provide condenser cooling air and exhaust air. Intake air louvers would need to be located in place of the storefront windows along the Second Place side of the building. The estimated size of the louvers are approximately 120 sq ft. of new louver area for intake air. These new louvers would be installed so that air can be ducted into the new Mechanical Equipment Room, with ductwork running through the existing 4th floor catwalk space. In order to provide exhaust air from the new chillers, we propose to utilize the existing skylight with a louvered exhaust opening, effectively removing the exhaust air from the chillers through the existing skylight opening. Modifications to the skylight and roof will be required. New piping will be run from the new chiller units to the existing chilled water main piping on the 2nd floor. New chilled water pumps will need to be provided to circulate water to all existing air handling units, and fan coil units. New electric power wiring and equipment will be required, and revisions to the building control sequence of operation will be required to incorporate the new equipment. In addition, further investigation into the adequacy of the building electric service will be needed during the design phase. It is recommended to engage in metering of the electric service to confirm the load on the existing electric distribution.
